Elevation

OFFICE OF PUBLIC WORKS

NATIONAL MONUMENTS AND HISTORIC PROPERTIES SERV

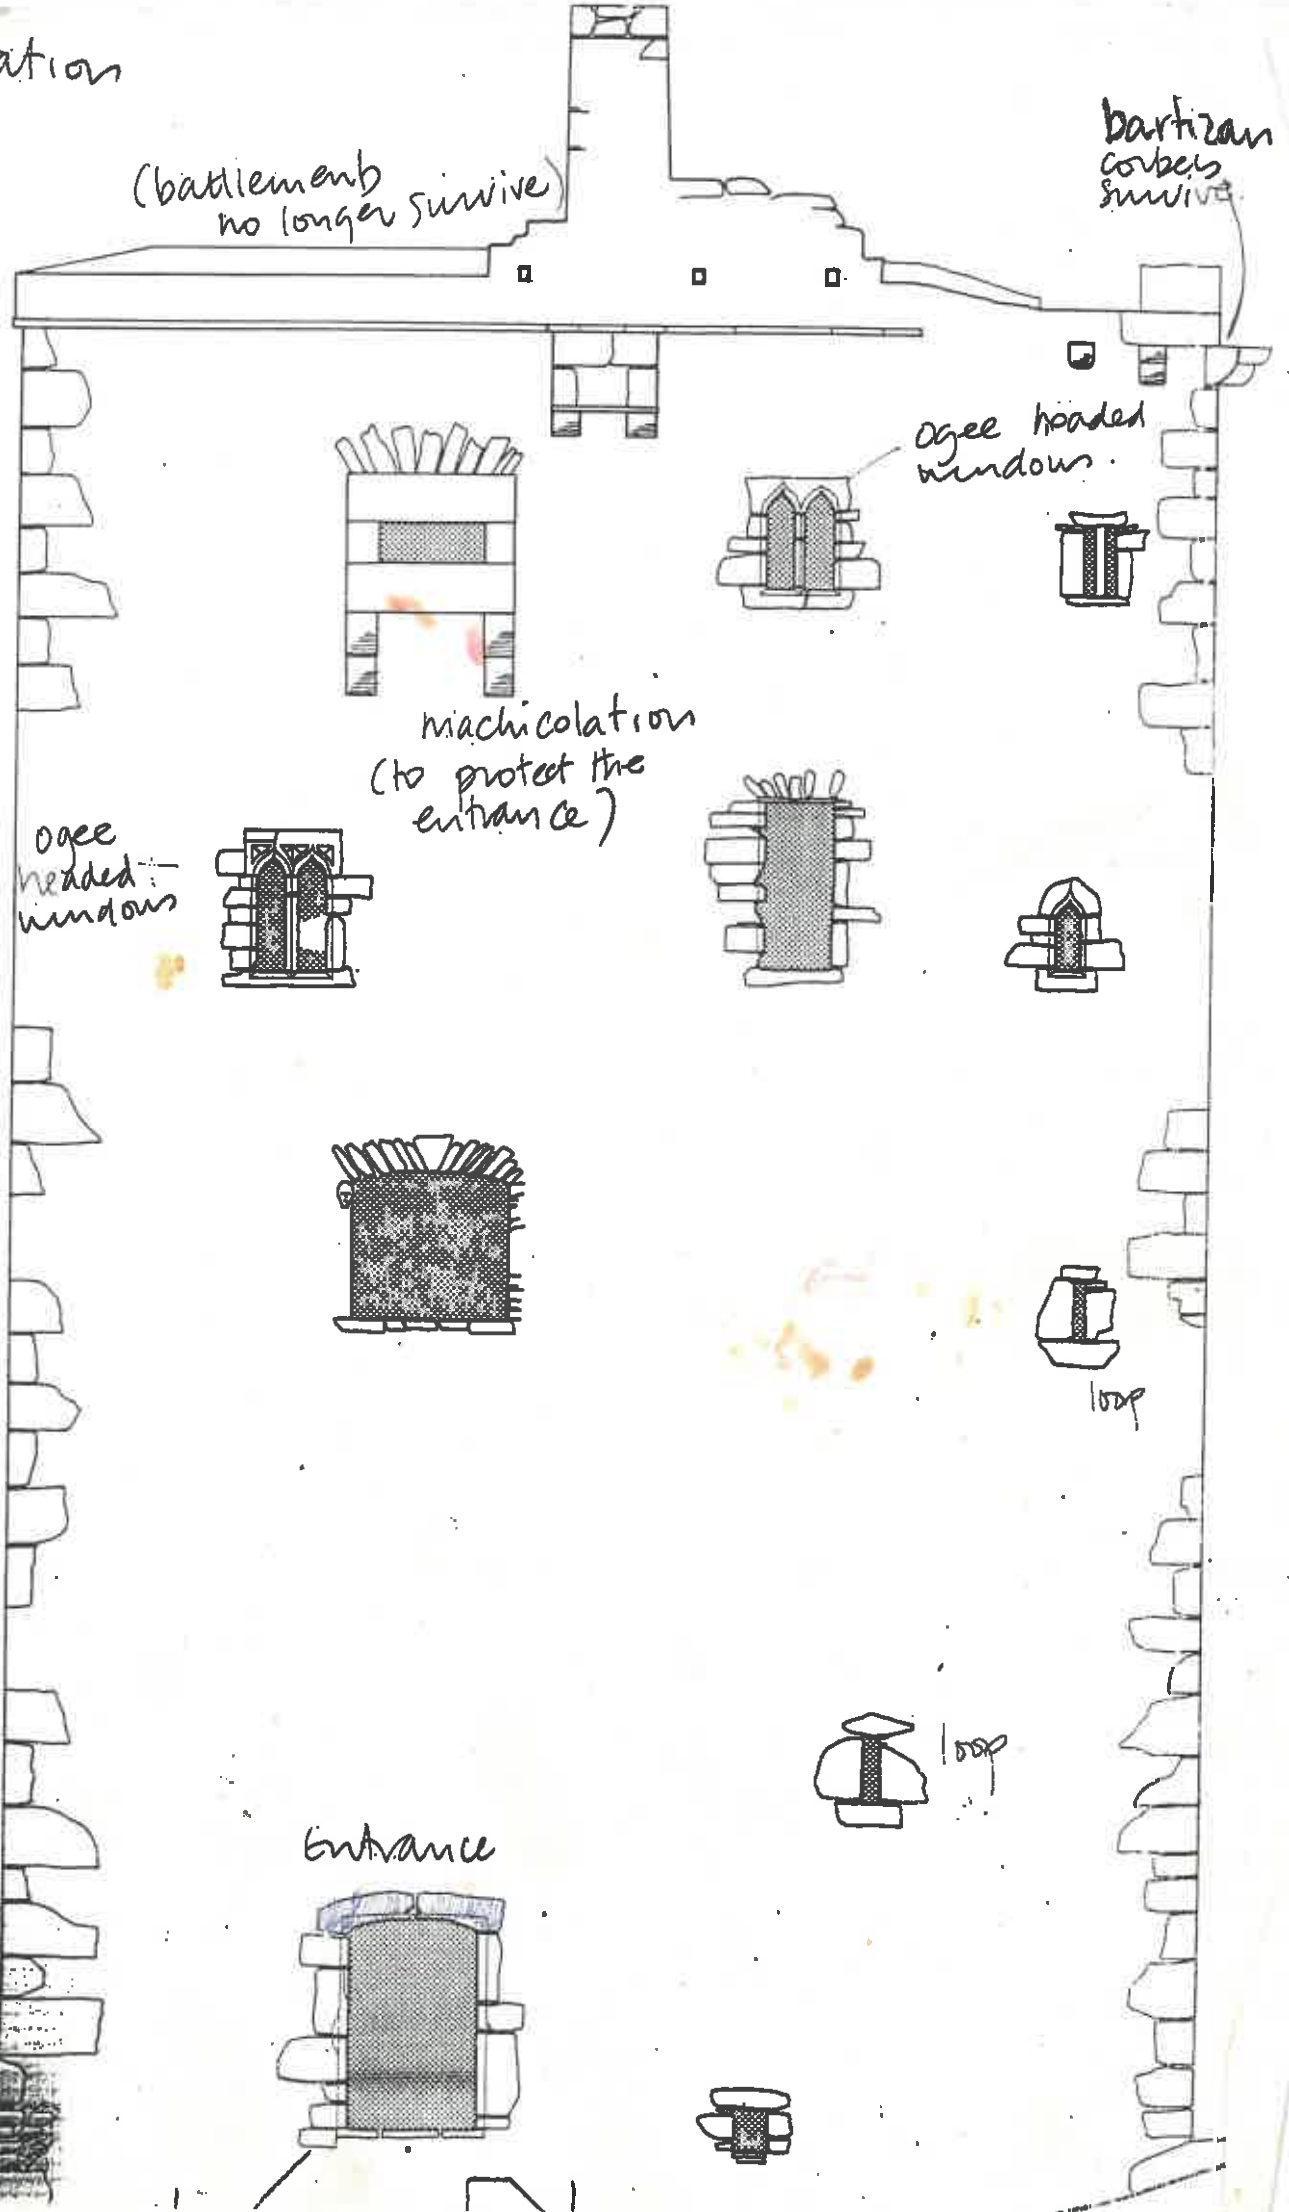
NE elevation

(battlements no longer survive)

battisan
corbels
survive

ogee headed
windows

machicolation
(to protect the
entrance)

ogee
headed
windows

loop

Entrance

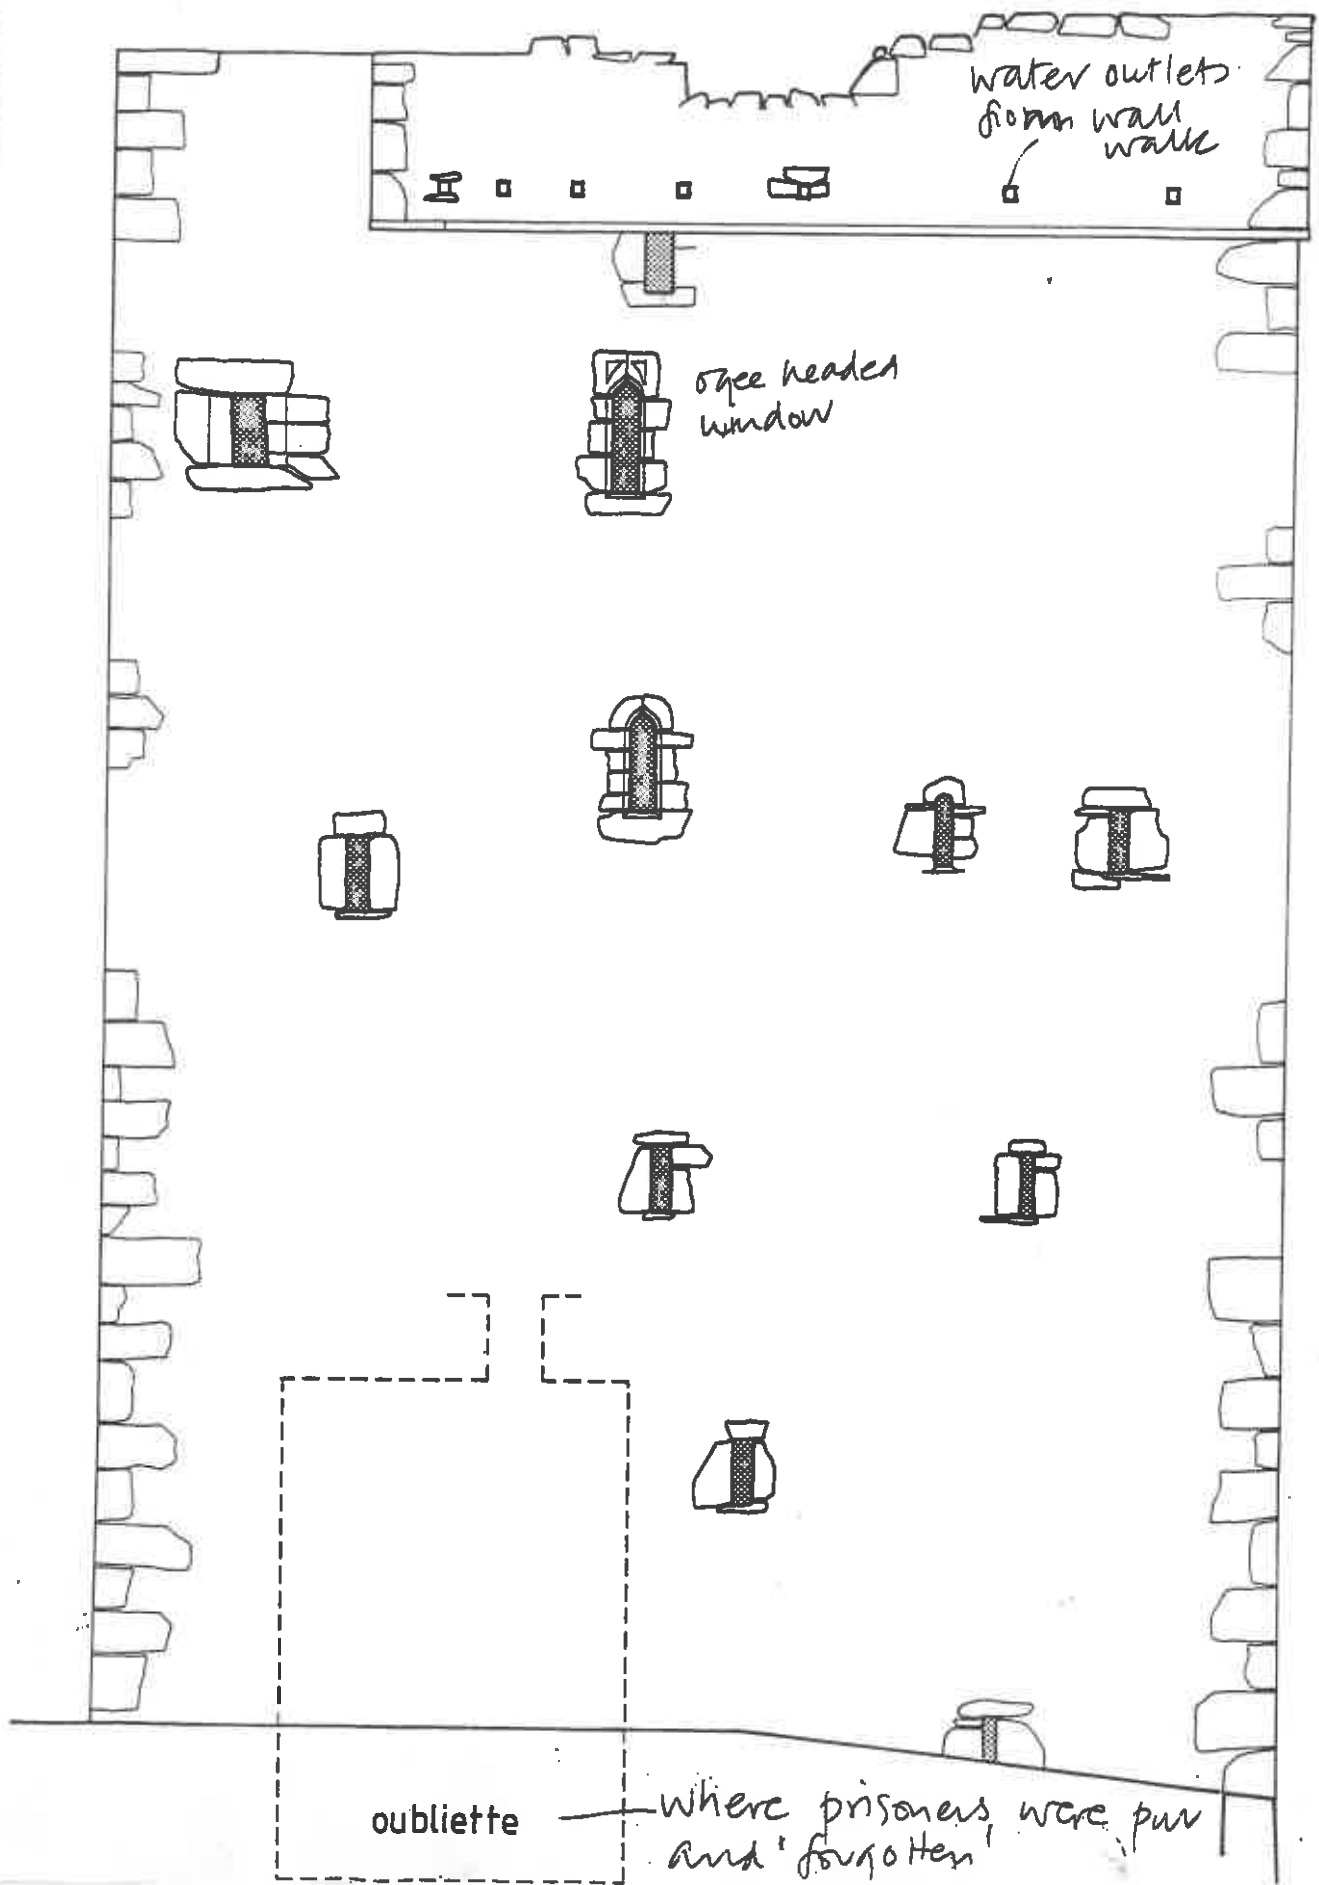
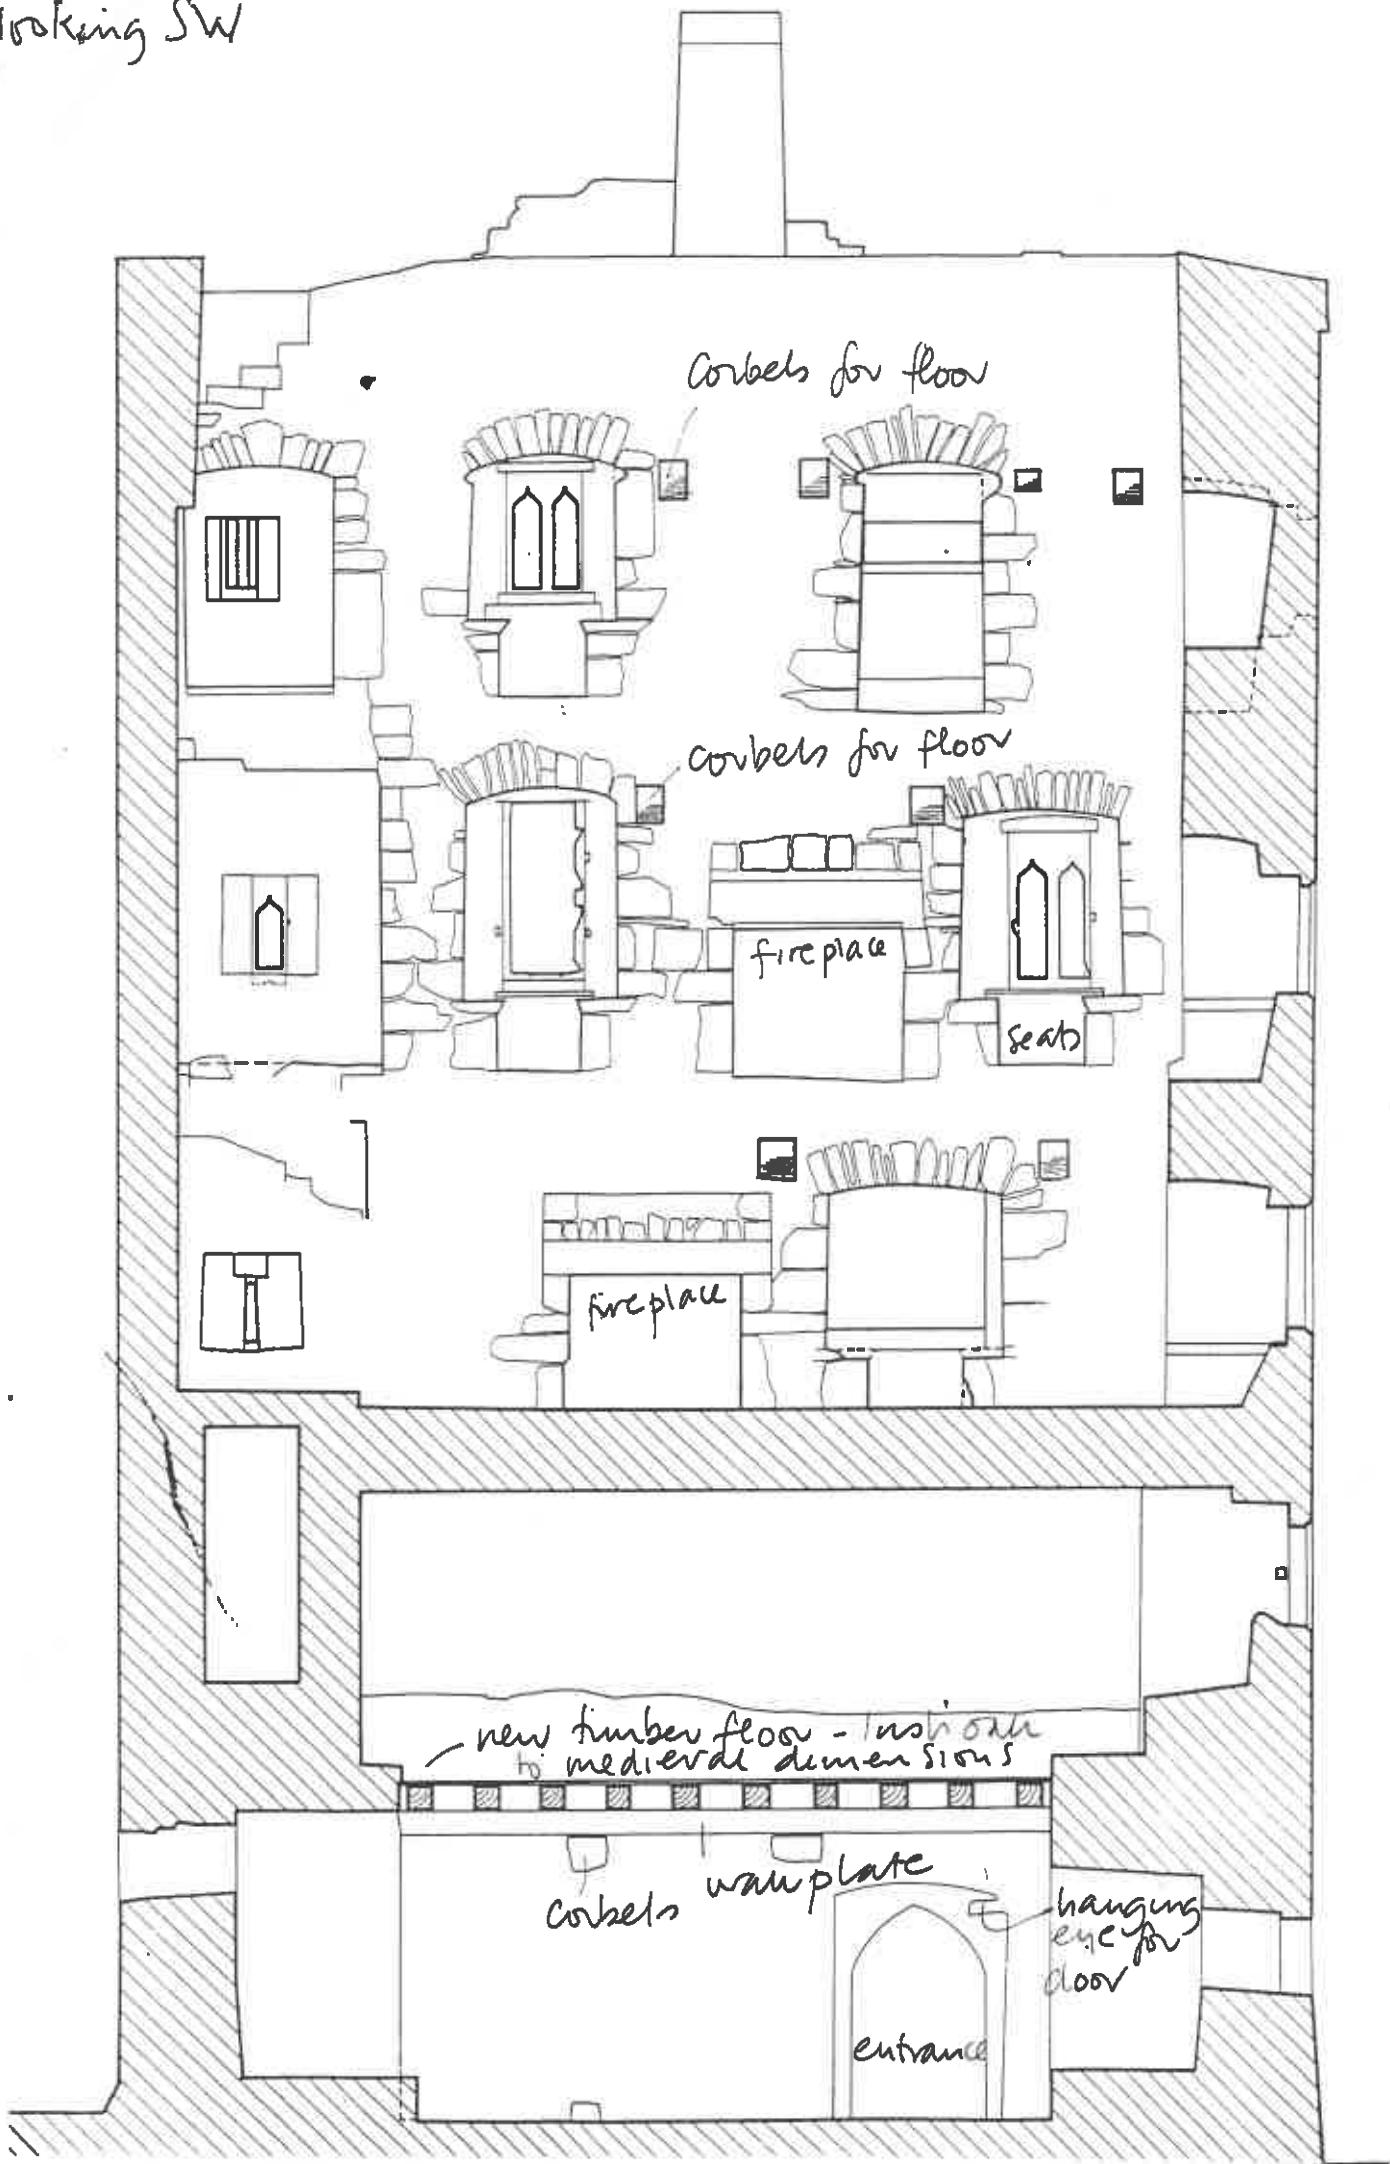
SECTION
looking SW

water outlets
from wall
walk

open headed
window

oubliette

where prisoners were put
and forgotten

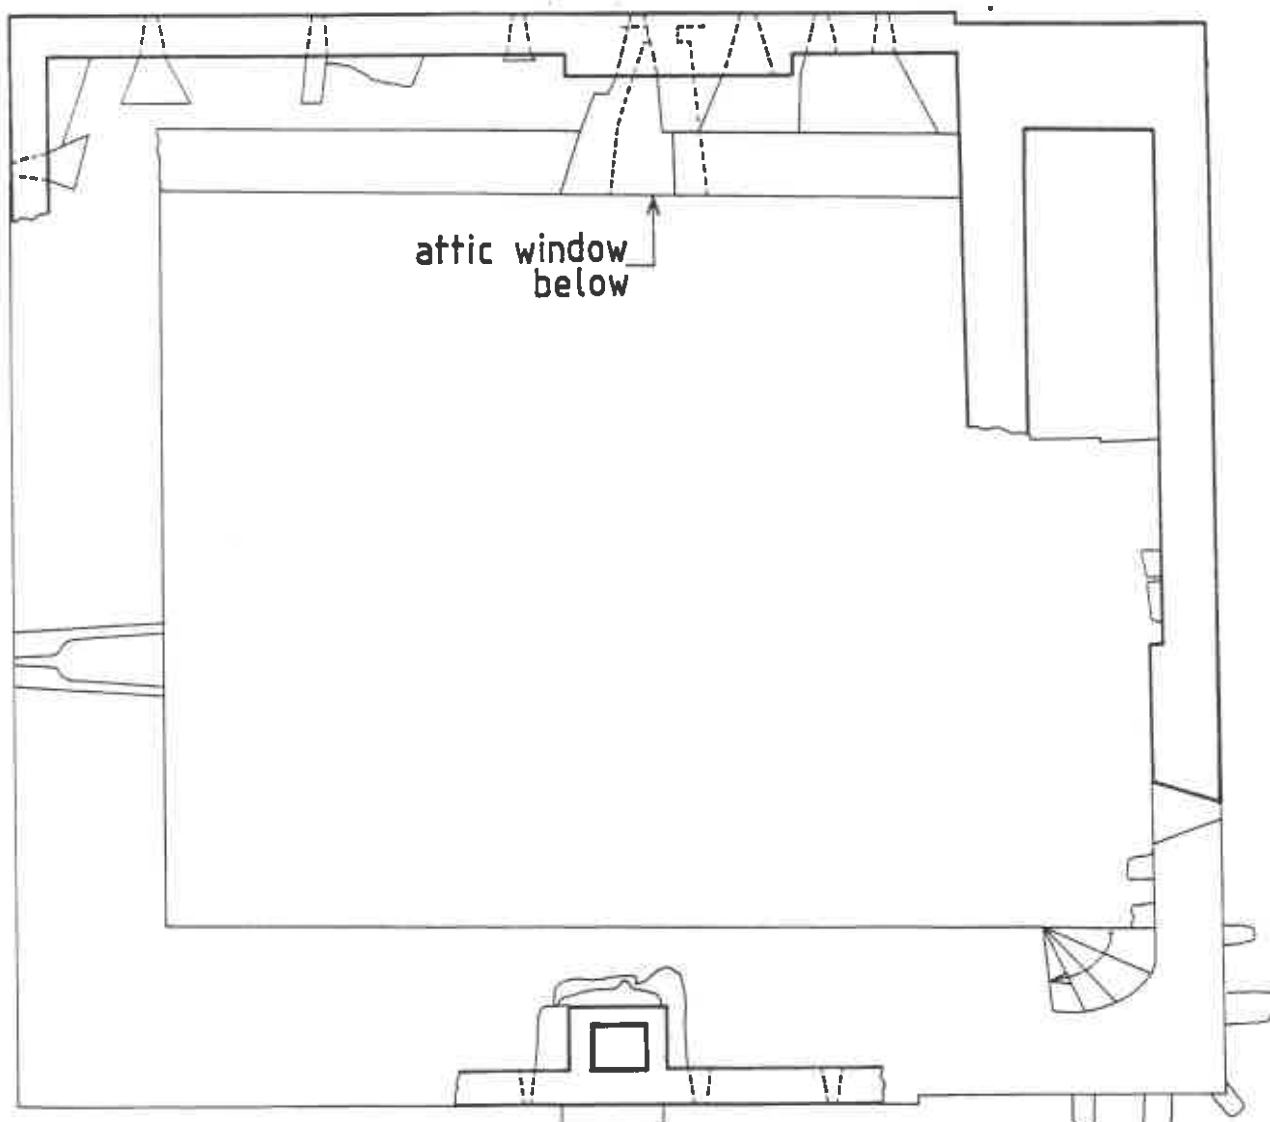
wall-walk plan

chimney
flue

bartizan
(defensive turret)
